**Re: Third Quarter 2024 Biofilter Inspection Technical Memorandum and Smoke Test Report**  
**Cedar Grove Composting – Maple Valley Facility**  
**Maple Valley, Washington**  
**Landau Project No. 1224005.110**

**RE:** Biofilter Inspections, Third Quarter 2024  
Cedar Grove Composting Facility  
Maple Valley, Washington

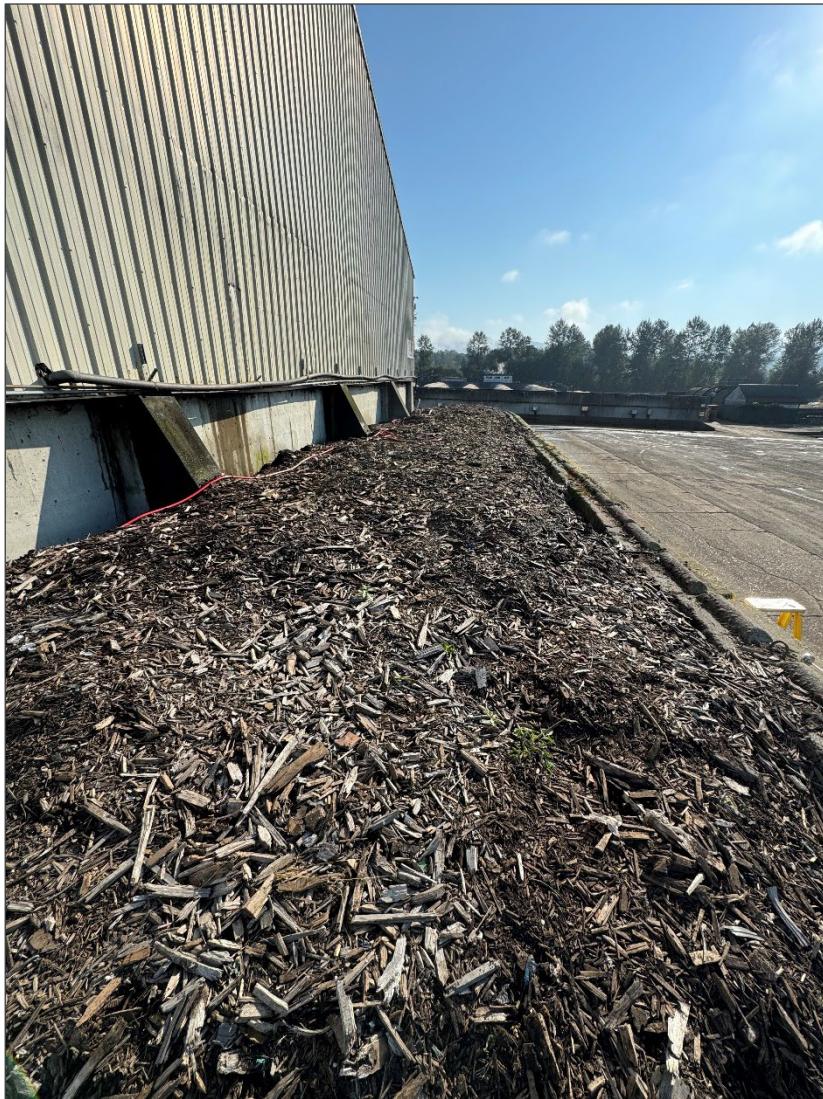
The Tipping Biofilter media were observed to have an average depth of approximately 8 feet. The media appear to have settled evenly. The surface media were observed to be moist across the surface and to a depth of at least 1.5 feet. Observed temperatures were between 63° and 68°F. The average bed temperature was 65.6°F, which is within the acceptable range for biofilter performance. A few rodent

holes and sparse plant growth were observed throughout the surface of the biofilter. No indicators of hotspot formation, cracks, or fissures were observed.

1. Tipping Building Biofilter.

Visually-observed operating parameters indicated that the biofilter is operating effectively, except for sparse plant growth and a few rodent holes. Raking and weeding of the biofilter surface were recommended to disturb plant growth and rodent holes. Sprinkling is recommended to maintain biofilter moisture.

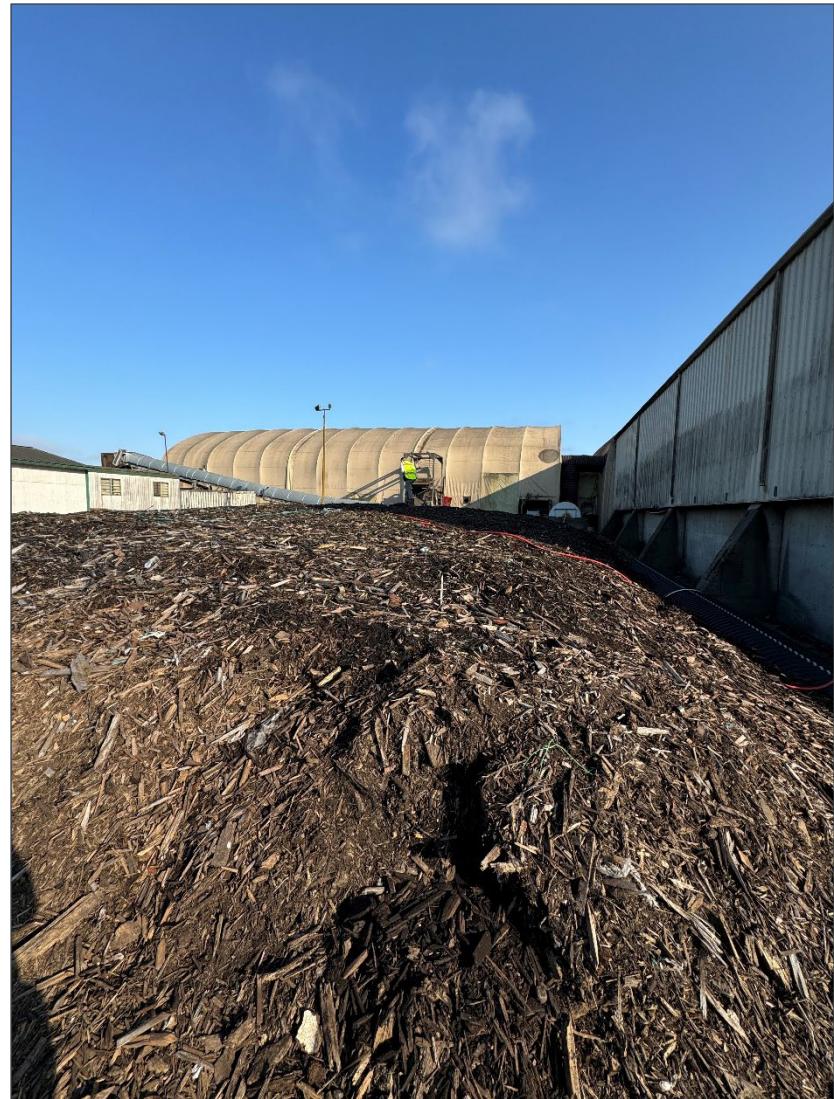
The Sorting/Grinding Building Biofilter media were observed to have an average depth of approximately 8 feet. The material has settled evenly. The surface media were observed to be moist across the surface and to a depth of at least 2 feet throughout the biofilter. Observed temperatures were between 54° and 78°F. The average bed temperature was 61.5°F, which is within the acceptable operating range. Several rodent holes and very sparse plant growth were observed throughout the surface of the biofilter. No indicators of hotspot formation, cracks, or fissures were observed.

- The moisture content of the biofilter was 60.2 percent, which is within the acceptable operating range.
- The void space of the biofilter was 41 percent, which is within the optimal operating range. Particle size degradation resulting in an increased bulk density and decreased void space is normal and expected in the biofilter aging process.
- The pH was 7.8, which is within the acceptable operating range. Additionally, ammonia concentrations were within the typical range of historical data. These laboratory-reported

2. Grinding Building Biofilter.

Visually-observed and laboratory-reported operating parameters indicated that the biofilter is operating effectively, except for several rodent holes and sparse plant growth. Raking and weeding of the biofilter surface were recommended to disturb rodent holes and plant growth. Sprinkling is recommended to maintain biofilter moisture.

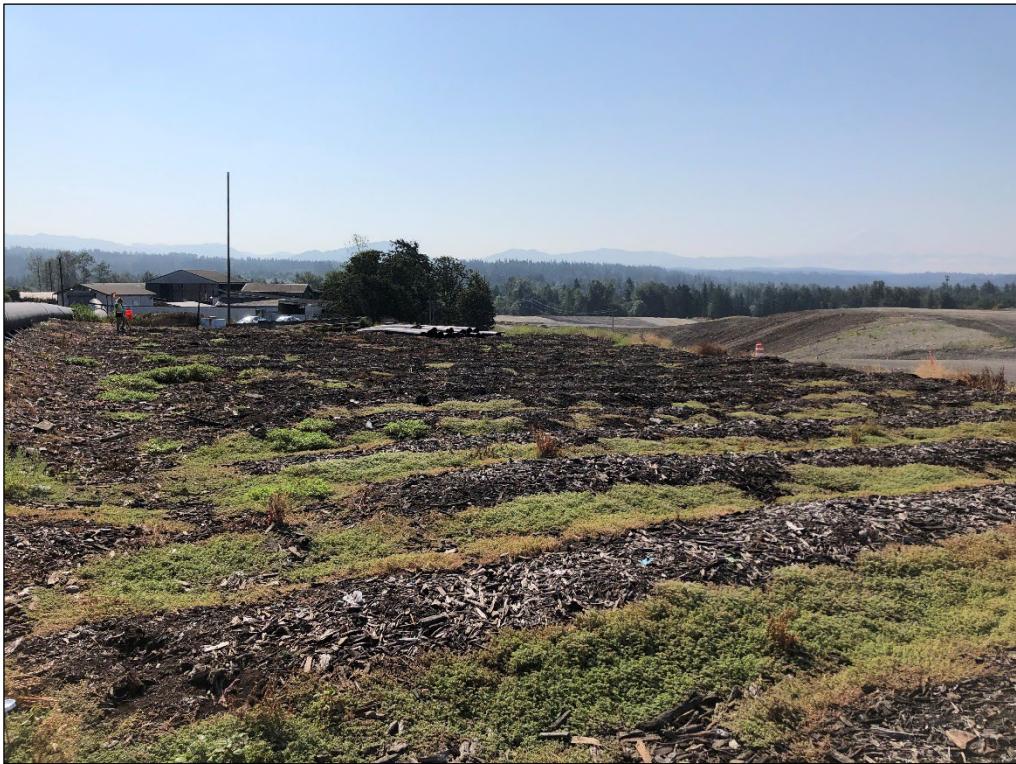
The Upper Primary Biofilter media were observed to have an average depth of approximately 5 feet. The material has settled evenly. The media were observed to be dry across the surface and moist starting at a depth of 0.5 feet to at least 2 feet. Observed temperatures were between 95° and 100°F. The average bed temperature was 97.0°F, which is within the optimal operating range. No indicators of rodent holes, hotspots, cracks, or fissures were observed. Heavy plant growth was observed throughout the surface of the biofilter.

- The moisture content of the biofilter was 48.5 percent, which is within the optimal operating range.
- The void space of the biofilter was 11 percent, which is below the acceptable operating range. Since EBRT is within the acceptable range, low void space is not an immediate concern, but will be monitored. Particle size degradation resulting in an increased bulk density and decreased void space is normal and expected in the biofilter aging process.
- The pH was 7.0, which is within the optimal operating range. Additionally, ammonia concentrations were within the typical range of historical data. These laboratory-reported chemical characteristics support the conclusion that the biofilter continues to perform acceptably and effectively.

3. Upper Primary Biofilter and Ventilation System.

Visually-observed and laboratory-reported operating parameters indicated that the biofilter is operating effectively, except for heavy plant growth throughout the biofilter and low void space. Raking and weeding of the biofilter surface were recommended to disturb plant growth. Sprinkling is recommended to maintain biofilter moisture. Void space will be monitored.

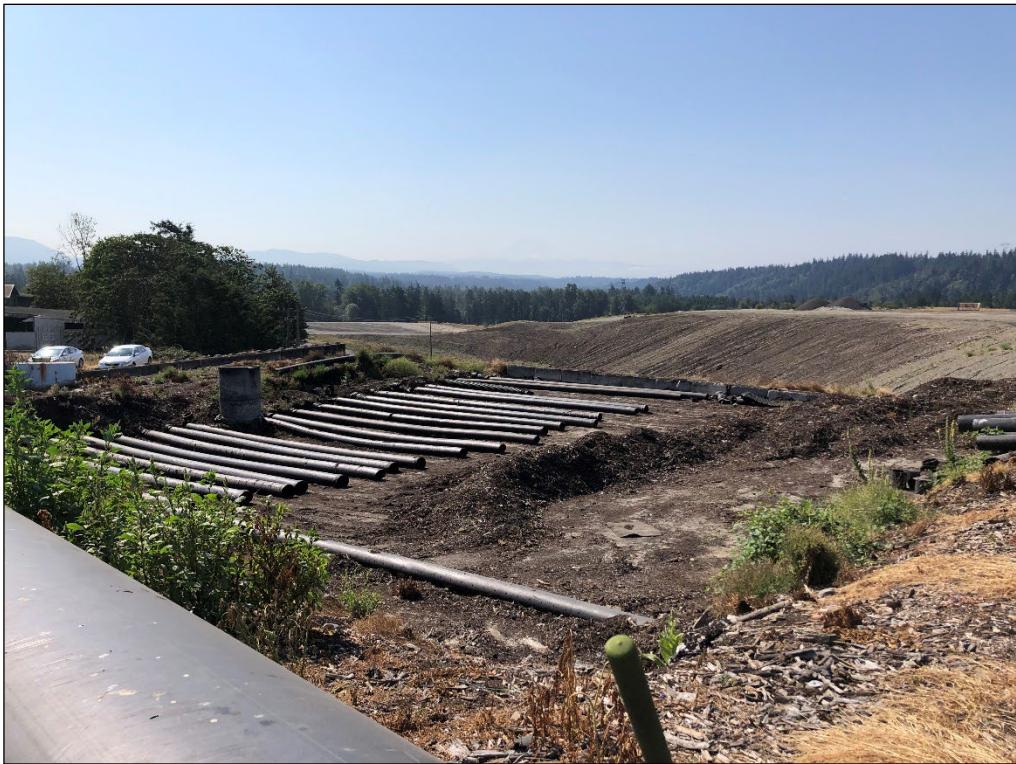
The Lower Primary Biofilter was undergoing maintenance at the time of inspection, including a complete replacement of biofilter media and inspection of the header and lateral pipes. During maintenance, all airflow is directed to the operating biofilter (in this case, the Upper Primary Biofilter). A photograph is provided in Attachment 6. Reconstruction of the biofilter is ongoing as Cedar Grove is experiencing setbacks regarding delivery of critical parts; it will be inspected again in the fourth quarter of 2024.

4. Lower Primary Biofilter and Ventilation System.

No recommendations are made, due to the maintenance in progress.

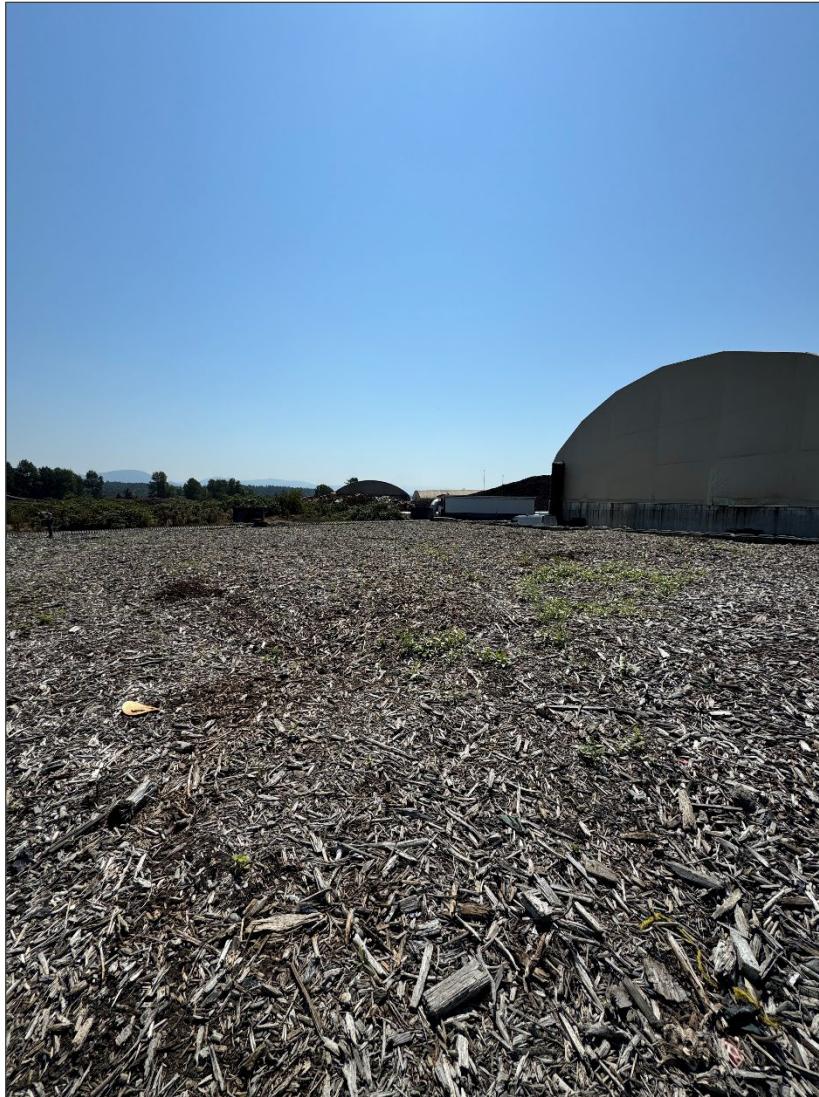
Media were observed to have a depth of approximately 4 feet. The material has settled evenly. The media were observed to be dry across the surface and to a depth of at least 2 feet. Observed temperatures were between 59° and 78°F. The average bed temperature was 64.7°F, which is within the acceptable operating range. No fissures or hotspots were observed. A few rodent holes and moderate plant growth were observed throughout the surface of the biofilter.

- The moisture content of the biofilter was 63.0 percent, which is within the acceptable operating range.
- The void space of the biofilter was 6 percent, which is below the acceptable operating range. Since EBRT is within the optimal operating range, low void space is not an immediate concern, but based on decreasing void space over the past two sampling periods, addition or replacement of media will be scheduled. Particle size degradation resulting in an increased bulk density and decreased void space is normal and expected in the biofilter aging process.
- The pH was 7.3, which is within the optimal operating range. Additionally, ammonia concentrations were within the typical range of historical data. These laboratory-reported chemical characteristics support the conclusion that the biofilter continues to perform acceptably and effectively.

5. West Secondary Biofilter.

Visually-observed and laboratory-reported operating parameters indicated that the biofilter is operating effectively, except for moderate plant growth, a few rodent holes, and low void space. Raking and weeding of the biofilter surface were recommended to disturb plant growth and rodent holes. Sprinkling is recommended as needed to maintain biofilter moisture. Addition or replacement of media will be scheduled.

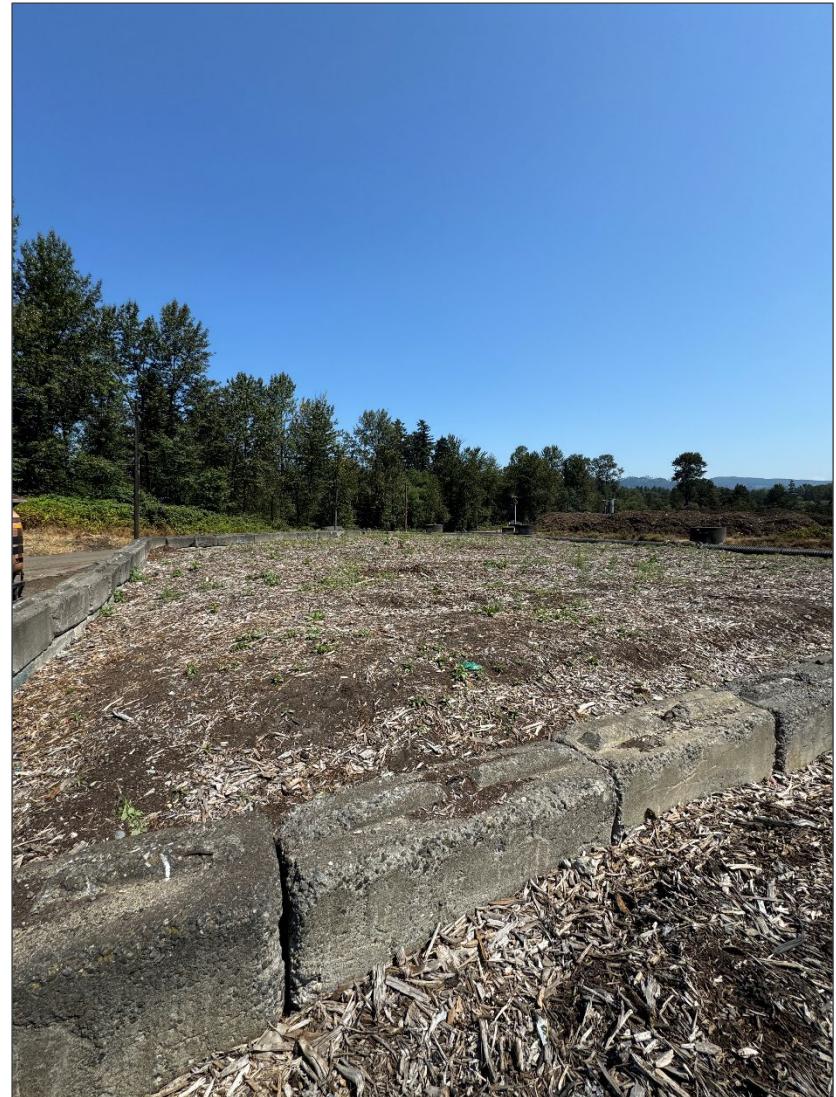
The East Secondary Biofilter media were observed to have an average depth of approximately 4 feet. The material has settled evenly. The media were observed to be dry across the surface and to a depth of at least 2 feet. Observed temperatures were between 69° and 73°F. The average bed temperature was 71.1°F. These temperatures were within the acceptable range for biofilter performance. Heavy plant growth was observed across the biofilter. No indicators of hotspots, rodent holes, or fissures were observed.

- The moisture content of the biofilter was 55 percent, which is within the optimal operating range.
- The void space of the biofilter was 7 percent, which is below the acceptable operating range. Since EBRT is within the optimal operating range, low void space is not an immediate concern, but based on decreasing void space over the past two sampling periods, addition or replacement of media will be scheduled. Particle size degradation resulting in an increased bulk density and decreased void space is normal and expected in the biofilter aging process.
- The pH was 6.9, which is within the optimal operating range. Additionally, ammonia concentrations were within the typical range of historical data. These laboratory-reported chemical characteristics support the conclusion that the biofilter continues to perform acceptably and effectively.

6. East Secondary Biofilter.

Visually-observed and laboratory-reported operating values indicate that the East Secondary Biofilter is operating effectively, except for heavy plant growth and low void space. Raking and weeding of the biofilter surface were recommended to disturb plant growth. Sprinkling is recommended to maintain biofilter moisture. Addition or replacement of media will be scheduled.
