**Re: First Quarter 2024 Biofilter Inspection Technical Memorandum and Smoke Test Report
Cedar Grove Composting – Maple Valley Facility
Maple Valley, Washington
Landau Project No. 1224005.110**

TECHNICAL MEMORANDUM

RE: Biofilter Inspections, First Quarter 2024
Cedar Grove Composting Facility
Maple Valley, Washington

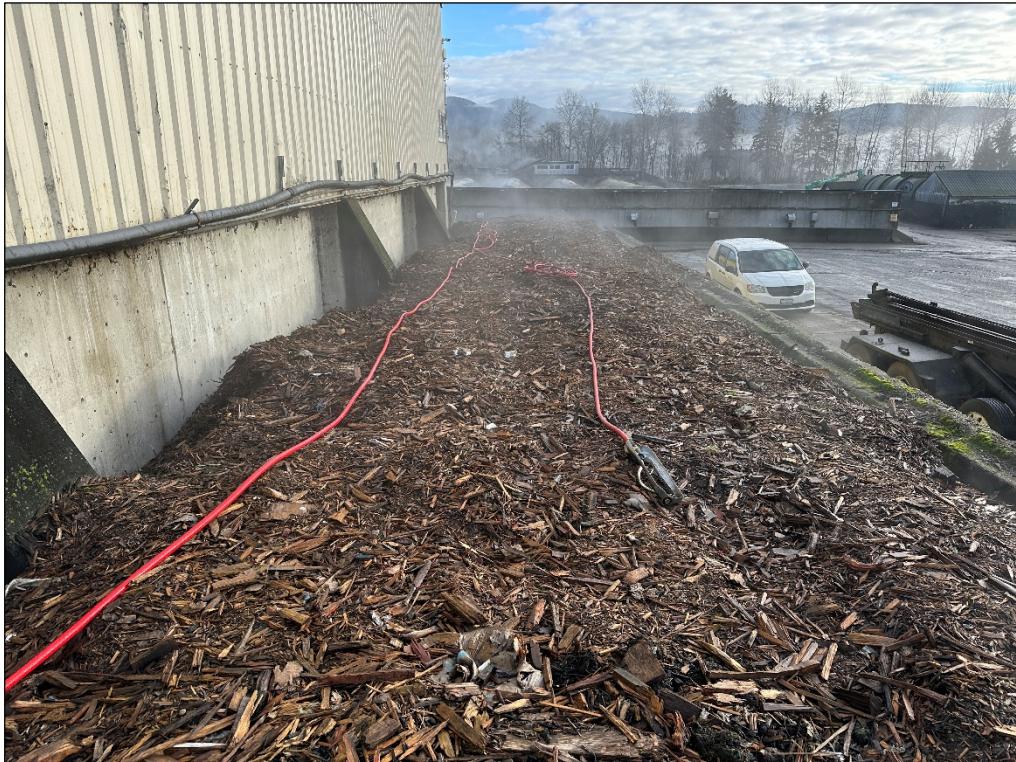
1. Tipping Building Biofilter.

The Tipping Biofilter media were observed to have an average depth of approximately 8 feet. The media appear to have settled evenly. The surface media were observed to be moist across the surface and to a depth of at least 2 feet. Observed temperatures were between 46° and 58°F. The average bed temperature was 53°F, which is slightly below the acceptable range for biofilter performance, but the lower temperatures were expected due to seasonal weather conditions. The bed temperature is

expected to come back into an acceptable operating range as the winter season ends. No indicators of rodent holes, hotspot formation, cracks, or fissures were observed. Scattered instances of plant growth was observed throughout the surface of the biofilter.

Visually-observed operating parameters indicated that the biofilter is operating effectively. Raking and weeding of the biofilter surface were recommended to disturb plant growth.

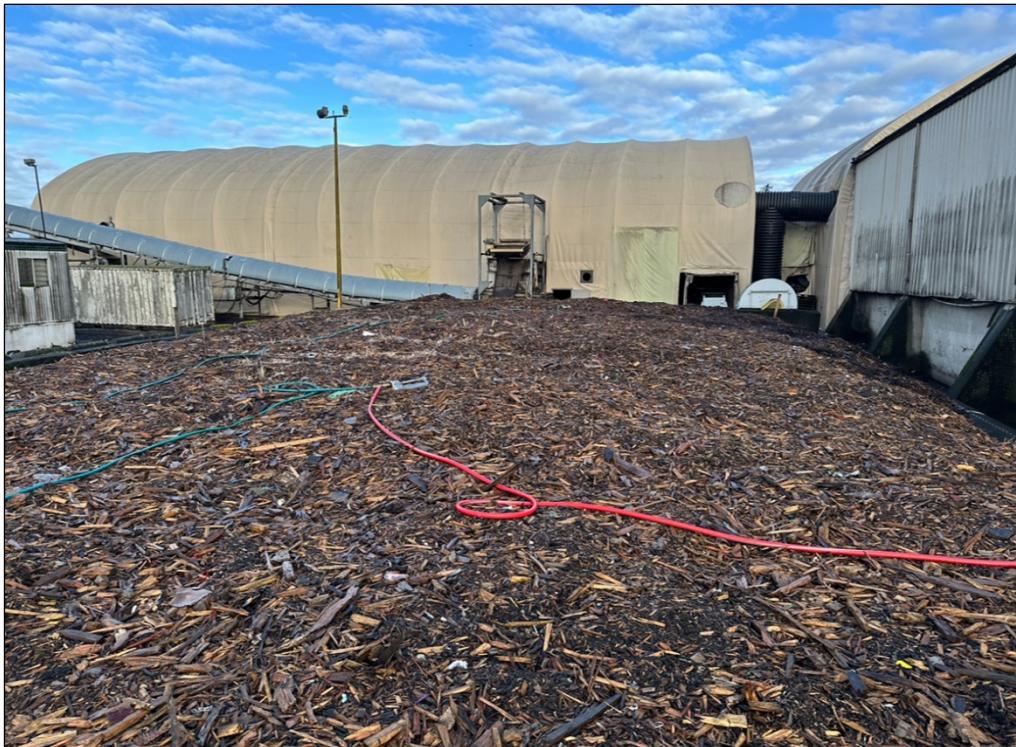
2. Grinding Building Biofilter.

The Sorting/Grinding Building Biofilter media were observed to have an average depth of approximately 8 feet. The material has settled evenly. The surface media were observed to be moist across the surface and to a depth of at least 2 feet throughout the biofilter. Observed temperatures were between 41° and 51°F. The average bed temperature was 46.9°F. These temperatures were below the acceptable range for biofilter performance, but the lower temperatures were expected due to seasonal weather conditions. The bed temperature is expected to come back into an acceptable operating range as the winter season ends. No indicators of hotspot formation, plant growth, cracks, or fissures were observed. A few rodent holes were observed throughout the biofilter.

- The moisture content of the biofilter was 59 percent, which is within the optimal operating range.
- The void space of the biofilter was 33 percent, which is within the optimal operating range. Particle size degradation resulting in an increased bulk density and decreased void space is normal and expected in the biofilter aging process.

Visually-observed and laboratory-reported operating parameters indicated that the biofilter is operating effectively, except for a few rodent holes. Raking of the biofilter surface was recommended to disturb rodent holes.

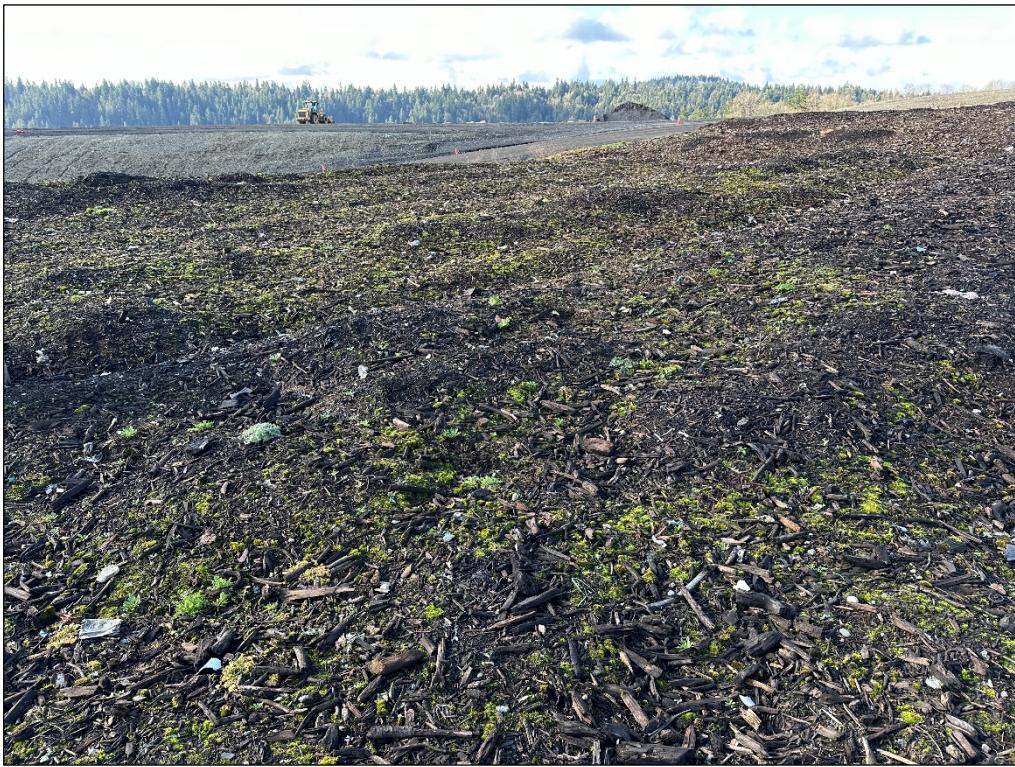
3. Upper Primary Biofilter and Ventilation System.

The Upper Primary Biofilter ventilation system was visually inspected for any indication of malfunction. The ventilation system appeared to be structurally sound, and no visual indicators of inoperability or malfunction (e.g., duct leaks or vent cracks) were observed. Air flow through the Upper Primary ventilation system was approximately 12,194 scfm. The resulting EBRT was 301 seconds, which is within the acceptable operating range. A photograph of the ventilation system is provided in Attachment 6.

The Upper Primary Biofilter media were observed to have an average depth of approximately 5 feet. The material has settled evenly. The media were observed to be moist across the surface and to a depth of at least 2 feet. Observed temperatures were between 52° and 70°F. The average bed temperature was 58.6°F, which is within the acceptable operating range. No indicators of rodent holes, hotspots, cracks, or fissures were observed. Scattered plant growth was observed throughout the surface of the biofilter.

- The moisture content of the biofilter was 57.7 percent, which is within the optimal operating range.
- The void space of the biofilter was 34 percent, which is within the optimal operating range. Particle size degradation resulting in an increased bulk density and decreased void space is normal and expected in the biofilter aging process.
- The pH was 6.2, which is within the optimal operating range. Additionally, ammonia concentrations were within the typical range of historical data. These laboratory-reported chemical characteristics support the conclusion that the biofilter continues to perform acceptably and effectively.

Visually-observed and laboratory-reported operating parameters indicated that the biofilter is operating effectively, except for scattered plant growth throughout the biofilter. Raking and weeding of the biofilter surface were recommended to disturb plant growth.

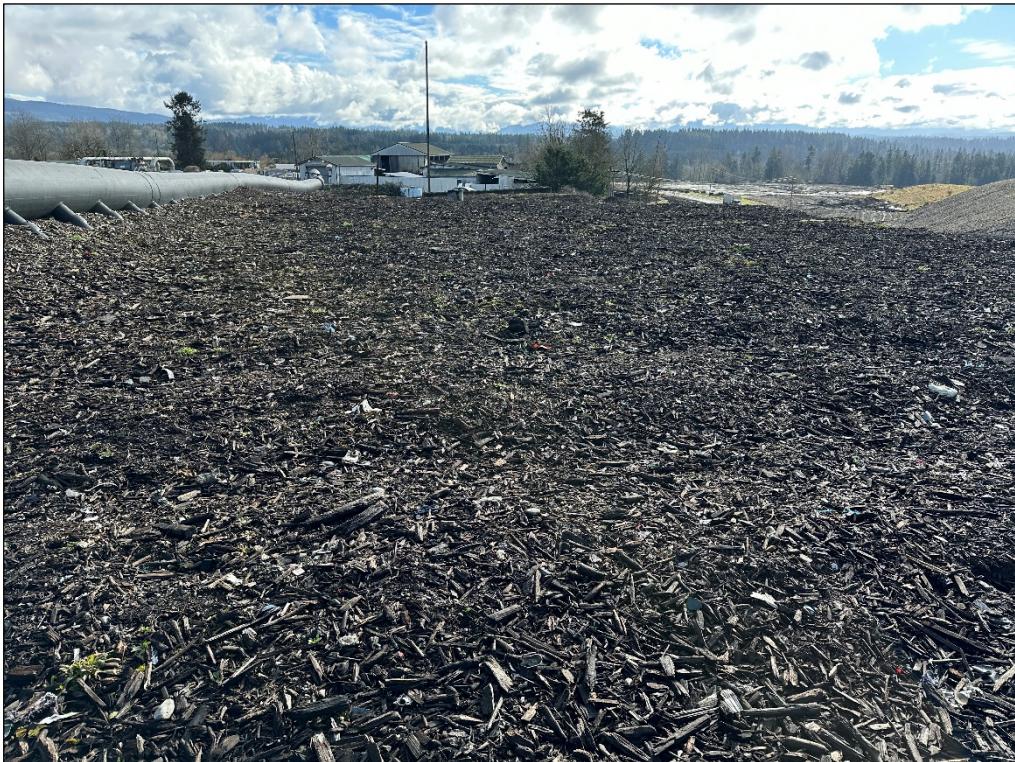
4. Lower Primary Biofilter and Ventilation System.

The Lower Primary Biofilter exhaust ventilation system was visually inspected for any indication of malfunction. All seals appeared to be in good working order. Overall, the ventilation system appeared to be structurally sound, and no visual indicators of inoperability were observed. Measured air flow through the Lower Primary fan was approximately 10,961 scfm. The resulting EBRT was 161 seconds, which is within the acceptable range, indicating that the biofilter continues to operate effectively with respect to biofilter performance. A photograph of the ventilation system is provided in Attachment 6.

The Lower Primary Biofilter media were observed to have an average depth of approximately 3 feet. The material has settled evenly. The surface media were observed to be moist across the surface and to a depth of at least 2 feet. Observed temperatures were between 69° and 73°F. The average bed temperature was 70.7°F, which is within the acceptable operating range. No rodent holes, fissures, or hotspots were observed. Scattered plant growth was observed throughout the surface of the biofilter.

Visually-observed operating parameters indicated that the biofilter is operating effectively, except for scattered plant growth throughout the biofilter. Raking and weeding of the biofilter surface were recommended to disturb plant growth.

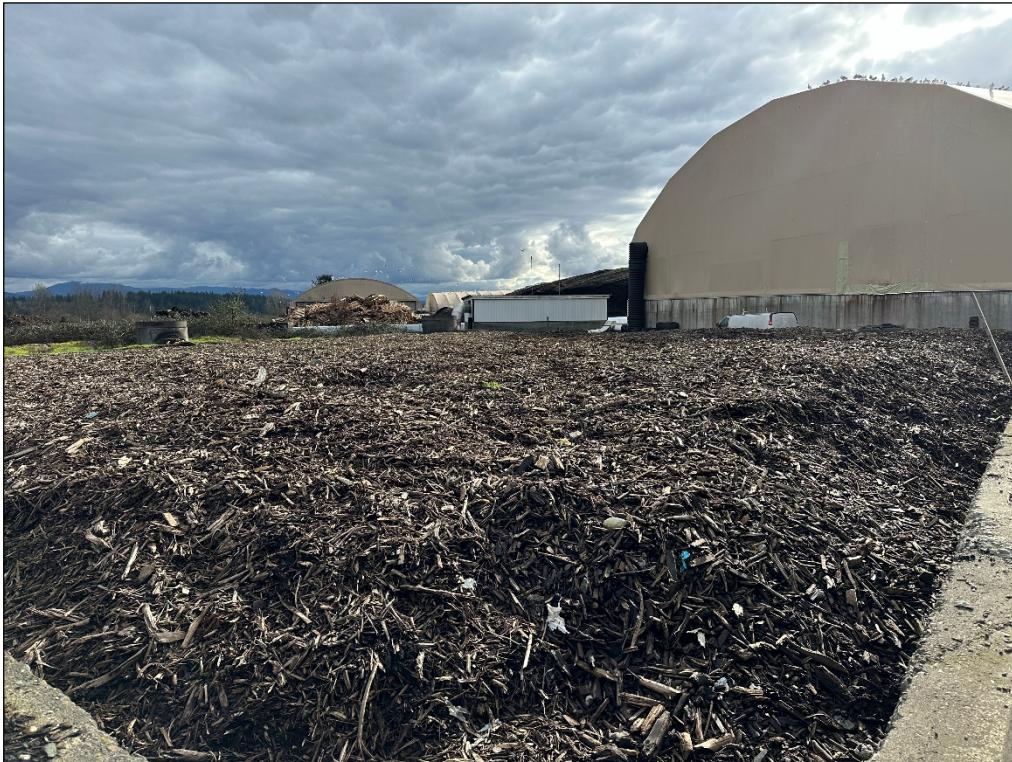
5. West Secondary Biofilter.

The West Secondary Biofilter ventilation system was visually inspected for any indication of malfunction. Most of the ventilation system is buried; the observable extent of the duct was visually inspected. No visual indicators of inoperability were observed. Measured air flow through the West Secondary ventilation system was approximately 26,433 scfm. The resulting EBRT was 121 seconds, which is within the acceptable range, indicating that the ventilation system continues to operate effectively.

Media were observed to have a depth of approximately 4 feet. The material has settled evenly. The media were observed to be moist across the surface and to a depth of at least 2 feet. Observed temperatures were between 53° and 64°F. The average bed temperature was 56.4°F. These temperatures were slightly below the acceptable range for biofilter performance, but the lower temperatures were expected due to seasonal weather conditions. The bed temperature is expected to come back into an acceptable operating range as the winter season ends. No rodent holes, fissures, or hotspots were observed. Scattered plant growth was observed throughout the surface of the biofilter.

- The moisture content of the biofilter was 65.9 percent, which is within the acceptable operating range.
- The void space of the biofilter was 3 percent, which is below the optimal operating range. Since EBRT is within the acceptable operating range, low void space is not an immediate concern, but based on decreasing void space over the past two sampling periods, addition or replacement of media will be scheduled. Particle size degradation resulting in an increased bulk density and decreased void space is normal and expected in the biofilter aging process.
- The pH was 6.6, which is within the optimal operating range. Additionally, ammonia concentrations were within the typical range of historical data. These laboratory-reported chemical characteristics support the conclusion that the biofilter continues to perform acceptably and effectively.

Visually-observed and laboratory-reported operating parameters indicated that the biofilter is operating effectively, except for scattered plant growth throughout the biofilter and low void space. Raking and weeding of the biofilter surface were recommended to disturb plant growth. Addition or replacement of media will be scheduled.

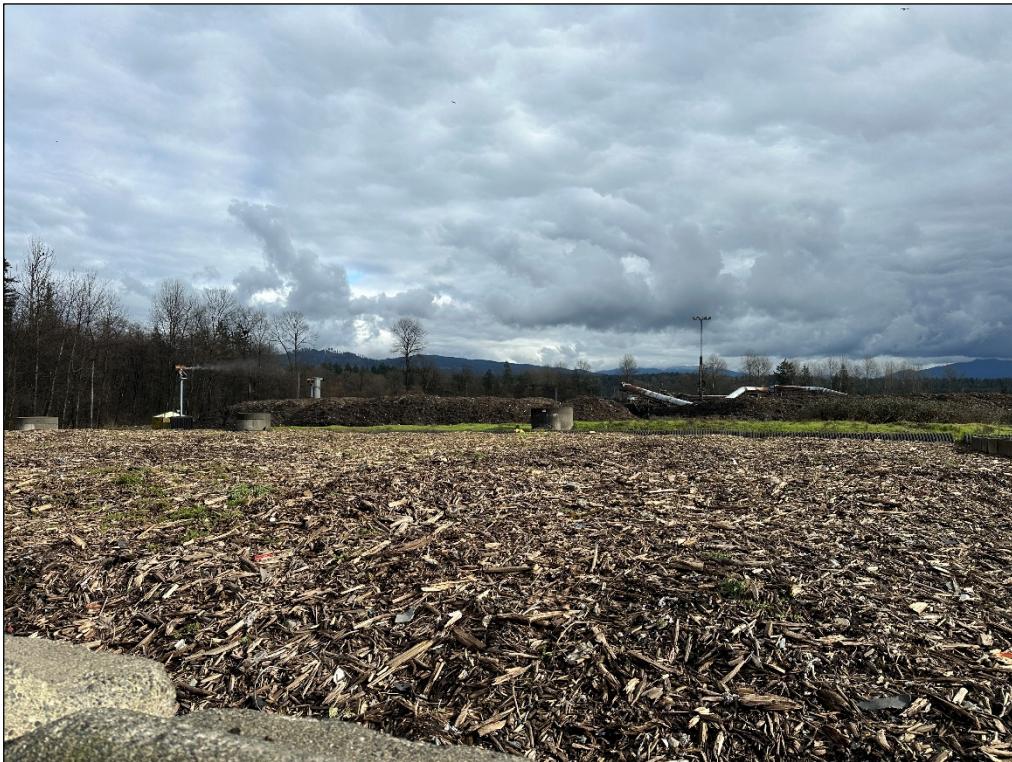
6. East Secondary Biofilter.

The East Secondary Biofilter ventilation system was visually inspected for any indication of malfunction. Most of the ventilation system is buried and the observable extent of the duct was visually inspected. From the observable extent, no visual indicators of inoperability or malfunction were observed. Measured air flow through the East Secondary ventilation system was approximately 29,649 scfm. The resulting EBRT was 185 seconds, which is within the acceptable range, indicating that the ventilation system continues to operate effectively. A photograph of the ventilation system is provided in Attachment 6.

The East Secondary Biofilter media were observed to have an average depth of approximately 5 feet. The material has settled evenly. The media were observed to be moist across the surface and to a depth of at least 2 feet. Observed temperatures were between 64° and 70°F. The average bed temperature was 67°F. These temperatures were within the acceptable range for biofilter performance. Moderate plant growth was observed across the biofilter. No indicators of hotspots, rodent holes, or fissures were observed.

- The moisture content of the biofilter was 63.5 percent, which is within the acceptable operating range.
- The void space of the biofilter was 9 percent, which is lower than the acceptable operating range. Since EBRT is within the acceptable operating range, low void space is not an immediate concern, but based on decreasing void space over the past two sampling periods, addition or replacement of media will be scheduled. Particle size degradation resulting in an increased bulk density and decreased void space is normal and expected in the biofilter aging process.
- The pH was 6.3, which is within the optimal operating range. Additionally, ammonia concentrations were within the typical range of historical data. These laboratory-reported chemical characteristics support the conclusion that the biofilter continues to perform acceptably and effectively.

Visually-observed and laboratory-reported operating values indicate that the East Secondary Biofilter is operating effectively, except for the moderate plant growth and low void space. Raking and weeding of the biofilter surface were recommended to disturb plant growth. Addition or replacement of media will be scheduled.
