**Re: First Quarter 2024 Biofilter Inspection Technical Memorandum and Smoke Test Report
Cedar Grove Composting – Maple Valley Facility
Maple Valley, Washington
Landau Project No. 1224005.110**

TECHNICAL MEMORANDUM

RE: Biofilter Inspections, First Quarter 2024
Cedar Grove Composting Facility
Maple Valley, Washington

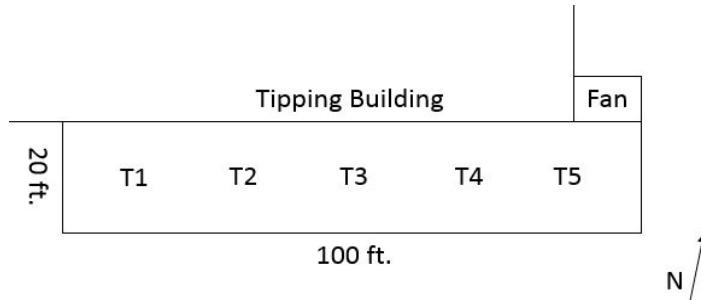
Attachment 1
Tipping Building Ventilation System and Biofilter Evaluation
Cedar Grove Composting
Maple Valley, Washington

Tipping Building	
Feedstock Stockpile Width =	100 ft
Feedstock Stockpile Depth =	40 ft
Feedstock Stockpile Height =	20 ft
Volume of Feedstock in Building =	80,000 ft ³
Building Capacity =	120,000 ft ³
Feedstock Percentage of Building Capacity =	67 %

Biofilter	
T1 =	46 °F
T2 =	52 °F
T3 =	55 °F
T4 =	54 °F
T5 =	58 °F
Average Bed Temperature =	53.0 °F
Area =	2,000 ft ²
Height =	8 ft
Volume =	16,000 ft ³
Residence Time =	0.97 min
	58 s

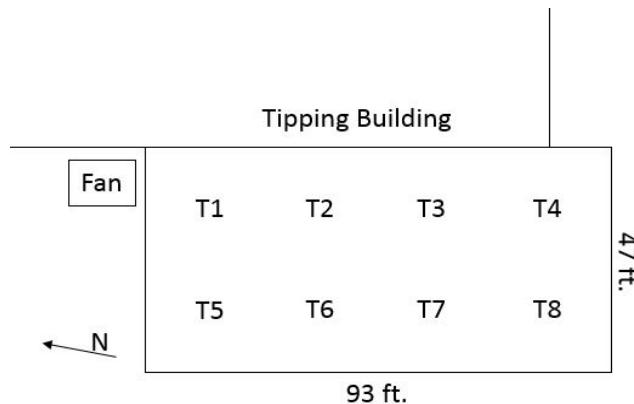
Attachment 2
Sorting/Grinding Building Ventilation System and Biofilter Evaluation
Cedar Grove Composting
Maple Valley, Washington

Ventilation System		
Building Fan Diameter =	48 in.	
Duct Area =	13 ft ²	
Temperature =	58.7 °F	
Velocity Pressure =	0.87 in. H ₂ O	
Static Pressure =	5.37 in. H ₂ O	
Stack Velocity =	3,199 ft/min	53 ft/s
Airflow =	40,203 ft ³ /min	40,925 scfm

Biofilter			
T1 =	49 °F	T5 =	47 °F
T2 =	51 °F	T6 =	47 °F
T3 =	48 °F	T7 =	50 °F
T4 =	41 °F	T8 =	42 °F
Average Bed Temperature =	46.9 °F		
Area =	4,371 ft ²		
Height =	8.0 ft		
Volume =	34,968 ft ³		
Residence Time =	0.87 min	52 s

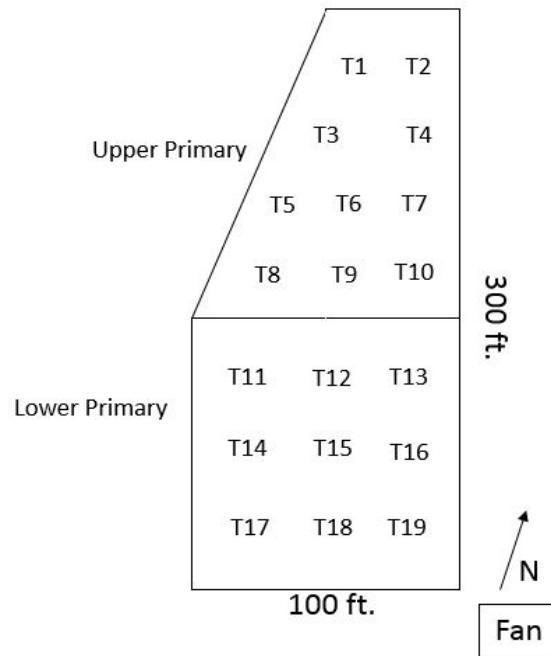
Lower Primary Ventilation System		
Building Fan Diameter =	48 in.	
Duct Area =	13 ft ²	
Temperature =	62 °F	
Velocity Pressure =	0.11 in. H ₂ O	
Static Pressure =	14.24 psia	
Stack Velocity =	890 ft/min	15 ft/s
Airflow =	11,179 ft ³ /min	10,961 scfm

Lower Primary Biofilter		
T11 =	70.0 °F	T16 = 72.0 °F
T12 =	71.0 °F	T17 = 70.0 °F
T13 =	70.0 °F	T18 = 69.0 °F
T14 =	73.0 °F	T19 = 70.0 °F
T15 =	71.0 °F	
Average Bed Temperature =	70.7 °F	
Area =	10,000 ft ²	
Height =	3 ft	
Volume =	30,000 ft ³	
Residence Time =	2.68 min	161 s

Total Primary Ventilation System and Biofilter	
Total Airflow =	23,534 ft ³ /min 23,155 scfm
Total Area =	22,400 ft ²
Total Height =	4 ft
Total Volume =	89,600 ft ³
Residence Time =	3.81 min 228 s

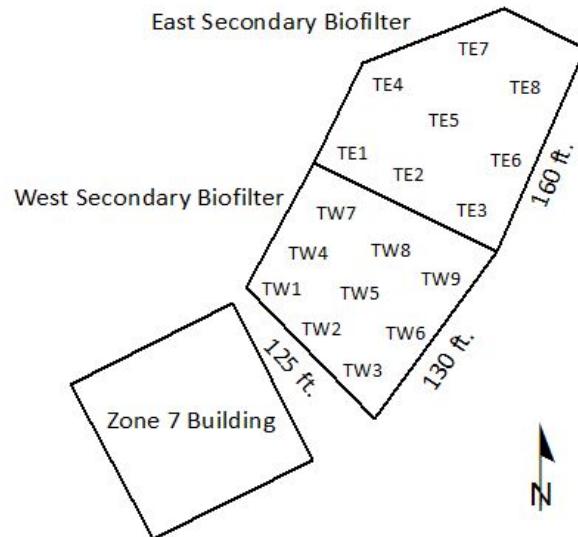
Secondary Compost Pile Ventilation System and Biofilter Evaluation
Cedar Grove Composting
Maple Valley, Washington

Zone 7 Building Fan	
Building Fan Diameter =	42 in.
Duct Area =	10 ft ²
Temperature =	52.95 °F
Velocity Pressure =	0.97 in. H ₂ O
Static Pressure =	1.80 in. H ₂ O
Stack Velocity =	3,982 ft/min 66 ft/s
Airflow =	38,308 ft ³ /min 39,432 scfm

Inlet 2 - West Biofilter Ventilation System	
Fan Diameter =	60 in.
Duct Area =	20 ft ²
Temperature =	55.0 °F
Velocity Pressure =	0.11 in. H ₂ O
Static Pressure =	0.48 in. H ₂ O
Stack Velocity =	1,313 ft/min 22 ft/s
Airflow =	25,782 ft ³ /min 26,433 scfm
